Reggie Fails to Proceed

By John McGary

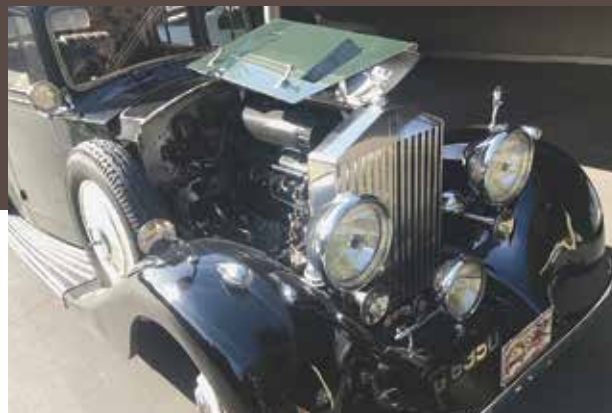
In the Westin Hotel garage Paul began the tedious task of removing the oil pump for inspection. Neither Paul nor Steve at this point could detect a problem. The oil pump was reinstalled by Paul. Next the oil line from the crankcase to the

firewall was removed from the car. It was discovered to be plugged. Paul used a can of Carburetor Cleaner to clear the line. After installing the oil line the gauge still showed no pressure. After a brief debate a trip to the auto store was made to purchase an oil gauge. The new gauge was lashed onto the oil line and upon running the engine it indicated perfect pressure. Paul and Steve agreed "bad gauge", problem solved. *One solution: Just leave the new gauge under the bonnet and proceed on the journey.*

Neither Anne nor I were not satisfied with the prospect of not having a visible oil gauge at the dash so together we disconnected the oil line at the oil gauge and while I was under the dash Anne blew Carburetor cleaner into the line from the firewall. We reassembled both lines removing the store bought gauge. Upon starting the engine the oil gauge did not respond. As disappointment began to show on my face, Anne suggested that I speed up the engine whereupon the oil gauge immediately sprung to life.

Final solution: Clear the remaining lines so the original gauge works again!

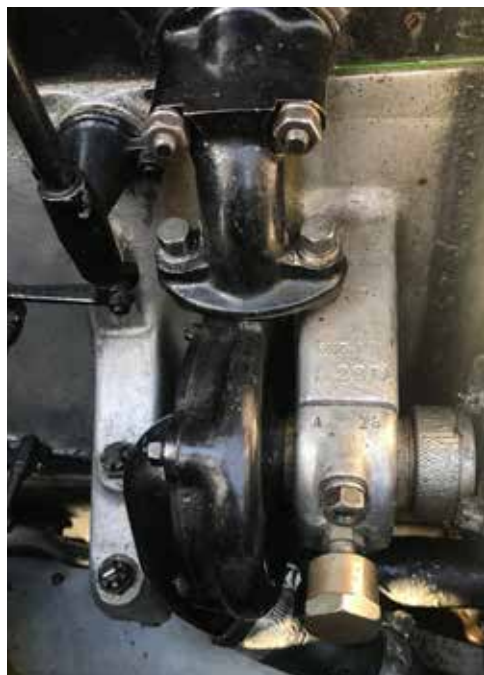
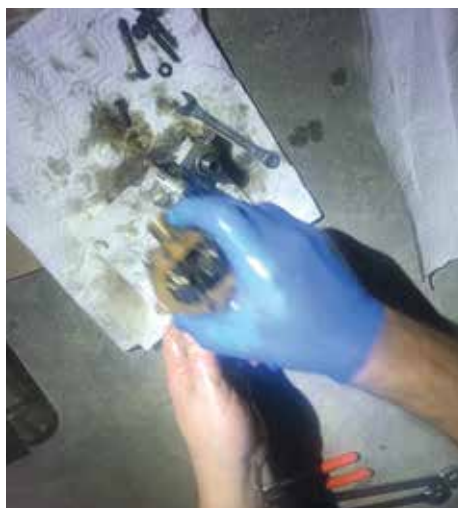
Steve returned to disassemble and repack the water pump. Steve made it look easy and could have done the job in his sleep. That just might come from years of experience. The result was Reggie was able to proceed for the rest of the journey in fine fashion. Not a drop of water has been added to the radiator since Whistler.
